# FACILITY COMPLIANCE INSPECTION REPORT

## Division of Waste Management Solid Waste Section

**Date of Site Inspection:** 11/08/2012

Avery Co. C&D Landfill  
 2175 Brushy Creek Rd. (SR-1011)  
 Spruce Pine, N.C.

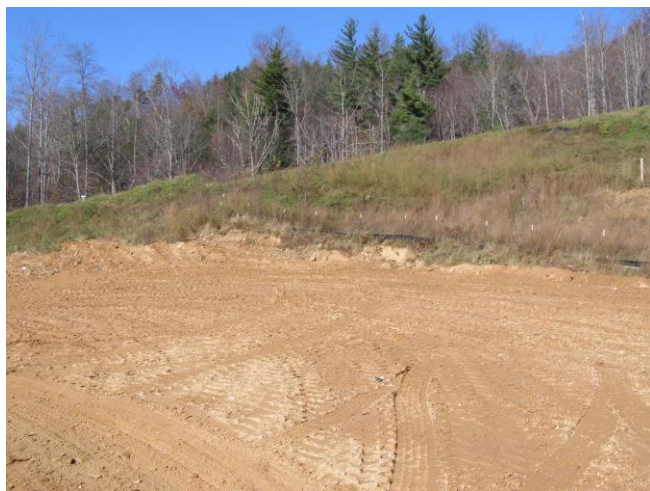
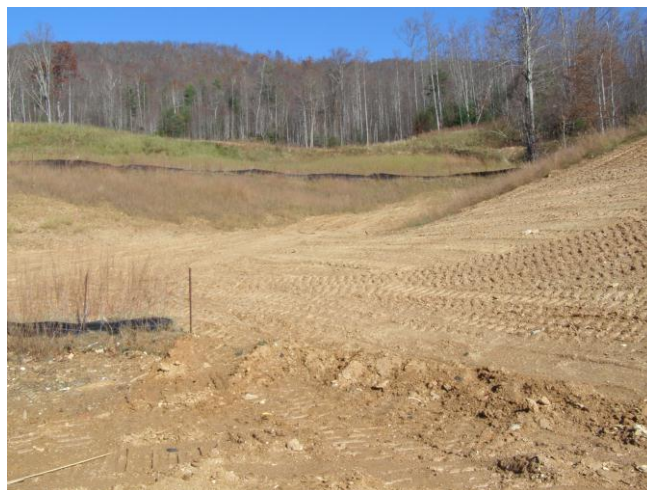
provided a written certification with supporting documentation confirming that the established compliance schedule was completed. During the inspection on November 8, 2012, the facility was in compliance with these rules.

Digital Photographs taken by Deb Aja on 11/8/2012. Views of areas of previously uncovered waste.

2. In response to violations observed on the October 11, 2012, the facility took immediate corrective actions in areas requiring cover and stabilization by shaping slopes to a 3 horizontal to 1 vertical slope and covering exposed wastes with a minimum of 6 inches of soil cover. These areas were hydro-seeded the week of October 22, 2012.
